ROOF INSPECTION REPORT

Town Garage

483 Stoughton Pond Rd.

Perkinsville VT

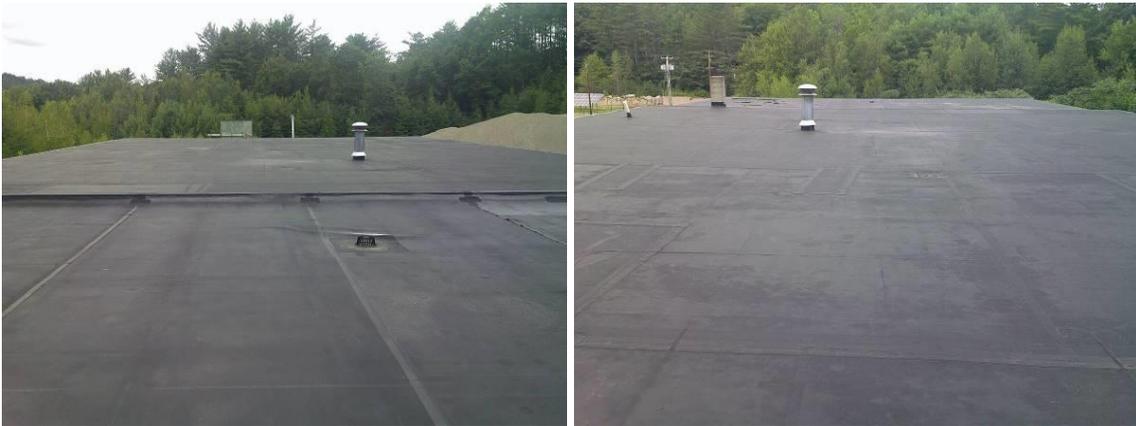
This building has a flat roof with rubber membrane roof covering. It appears and/or is reported to be approximately 40 years old. Concrete block and metal chimneys are located at the central portion.

During my inspection, I found the rubber membrane roof covering to be moderately weathered, in a manner consistent with its age. One might reasonably expect at least several (three to five) years remaining serviceable life, with need for replacement increasingly likely thereafter.

At such time that a new roof covering is required, I recommend replacement with a rubber membrane system, similar to the current type, which may be expected to yield a total of 40 or more years of serviceable life. Expect roof covering replacement cost to range between \$40000 and \$60000 in today's dollars.

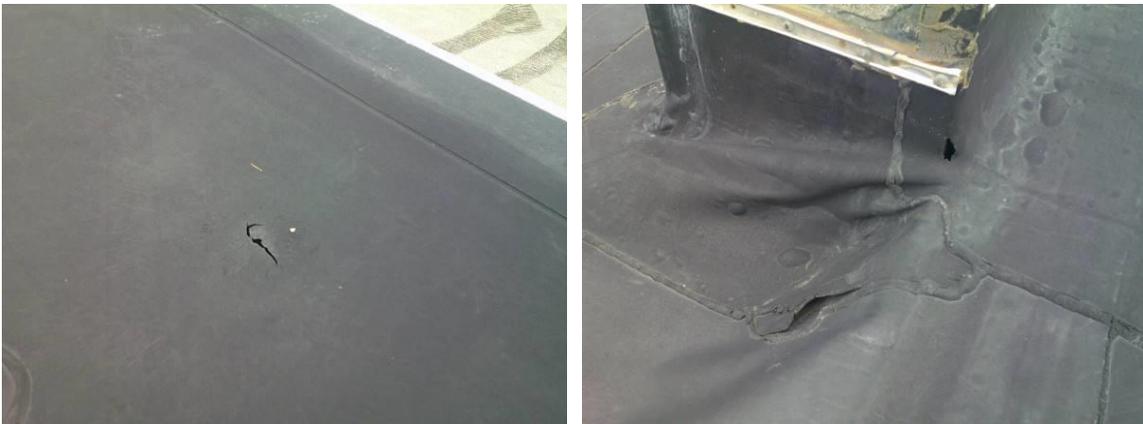
I noted damage (holes) in the rubber membrane at several locations, particularly at locations near the south edge and concrete block chimneys. Also, I noted lifting at membrane seams at several locations. These areas should be repaired as soon as possible to protect against water penetration.

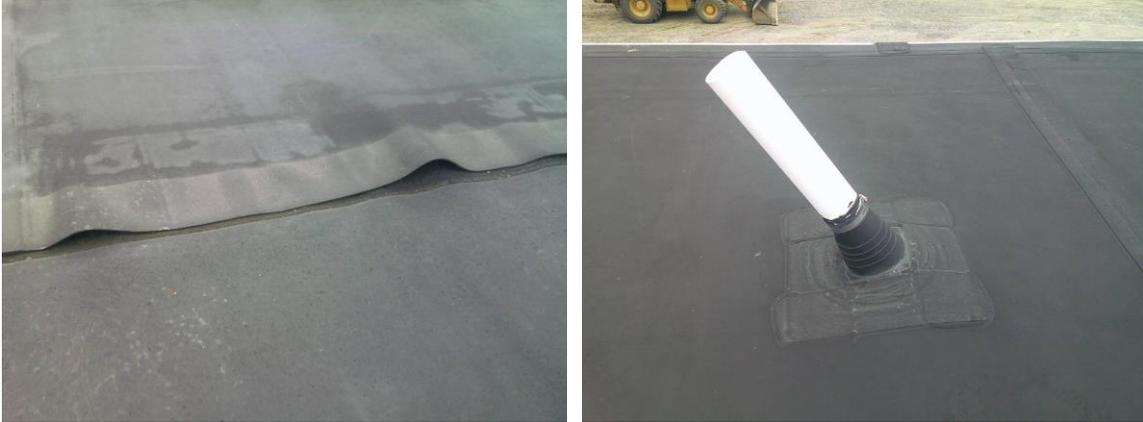
Also, I noted lifting a roof vent pipe that was poorly (loosely) secured and leaning over during my inspection. While this does not present a roof leak risk, it is an indication that the pipe is broken below the surface, and should be repaired.
