## **ROOF INSPECTION REPORT**

8/10/22

West Weathersfield Fire Station

7259 Route 131

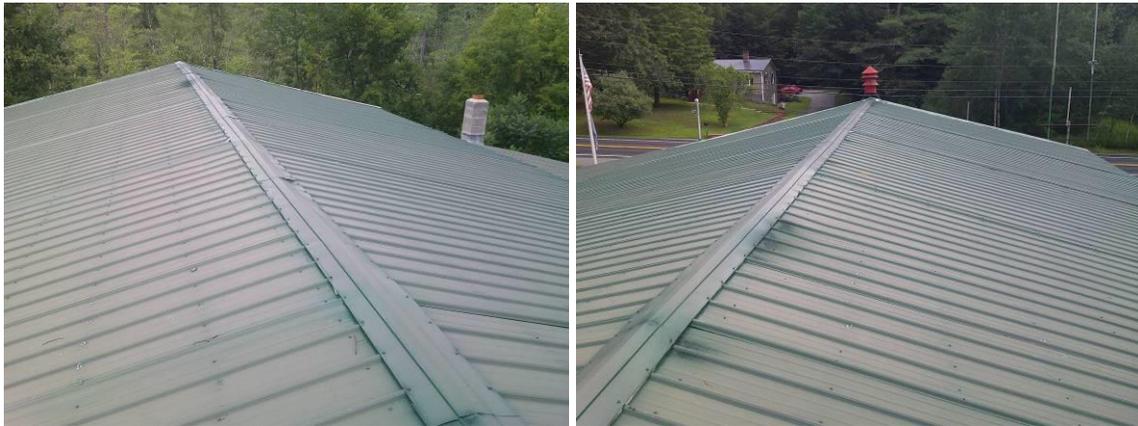
This building has a gable roof with corrugated metal panel roof covering. It appears and/or is reported to be approximately 20 years old. A concrete block chimney is located at the west portion.

During my inspection, I found the roof covering to be moderately weathered overall, in a manner consistent its age. One might reasonably many (five plus) years remaining serviceable life.

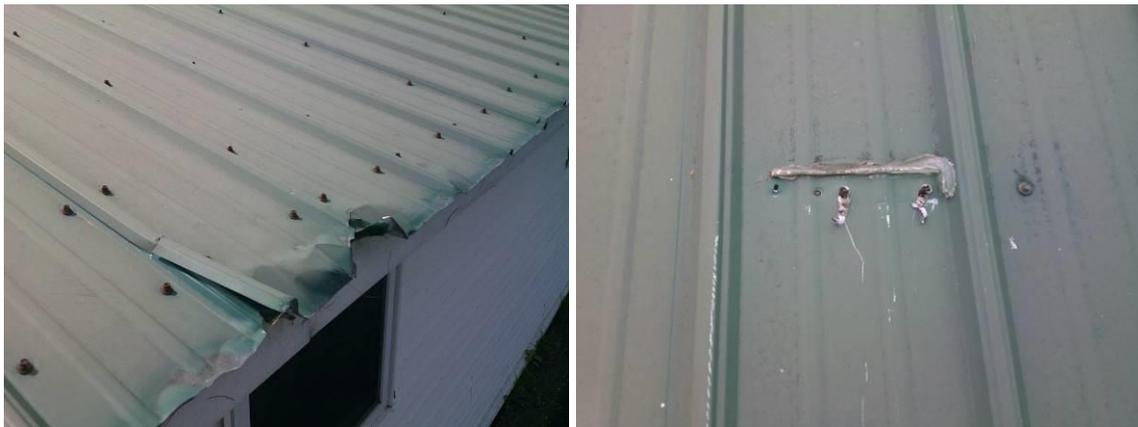
I noted metal panel damage at the east eave. Also, I noted open holes at the east pitch where the electrical masthead bracket used to be (but has pulled loose). I recommend repairs at these areas to protect against water penetration into the interior of this building.

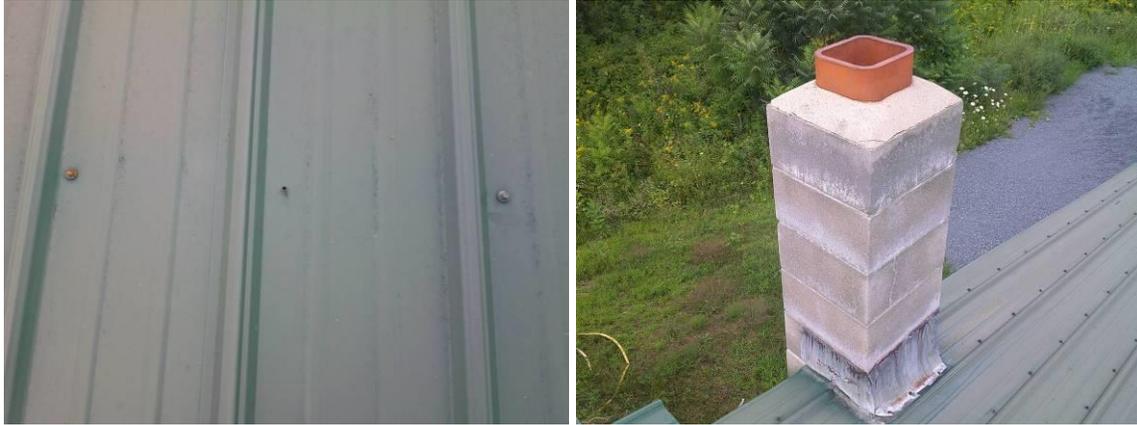
Corrugated metal roof panel fasteners (nails and/or screws) can work loose over time and lose their seal. Care should be taken to tighten/replace fasteners where loose. I noted

several areas where roof fasteners had loosened or were missing at this building during my inspection. I recommend repair. Also, I recommend installing a chimney cap to help prevent water, pest and debris entry into the flue, and to reduce chimney deterioration over time.
