ROOF INSPECTION REPORT

Martin Memorial Hall

5259 US Route 5

Ascutney VT

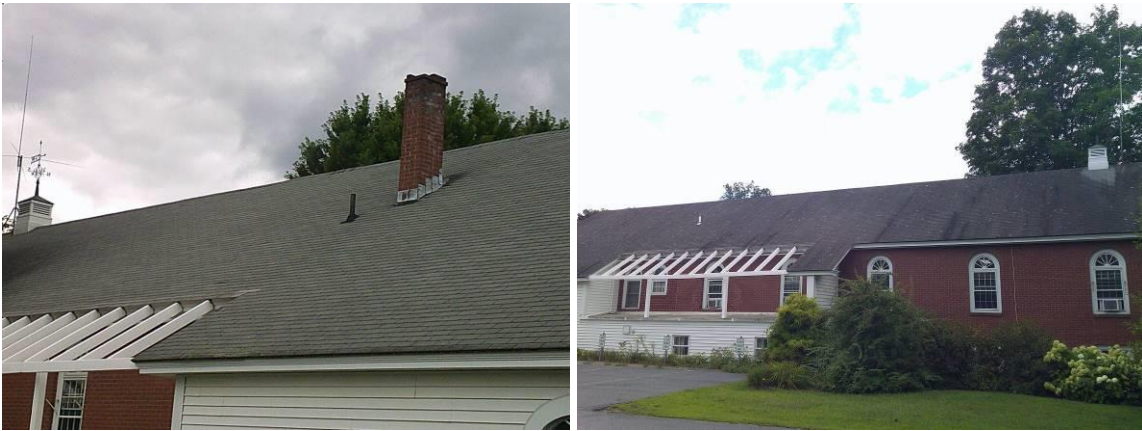
During my inspection, I found the asphalt shingle roof covering to be moderately weathered, in a manner consistent with its age. One might reasonably expect several (three to five) years remaining serviceable life, with need for replacement increasingly likely thereafter. The rubber membrane roof coverings appeared in good condition, with many more (five plus) years remaining serviceable life to be expected.

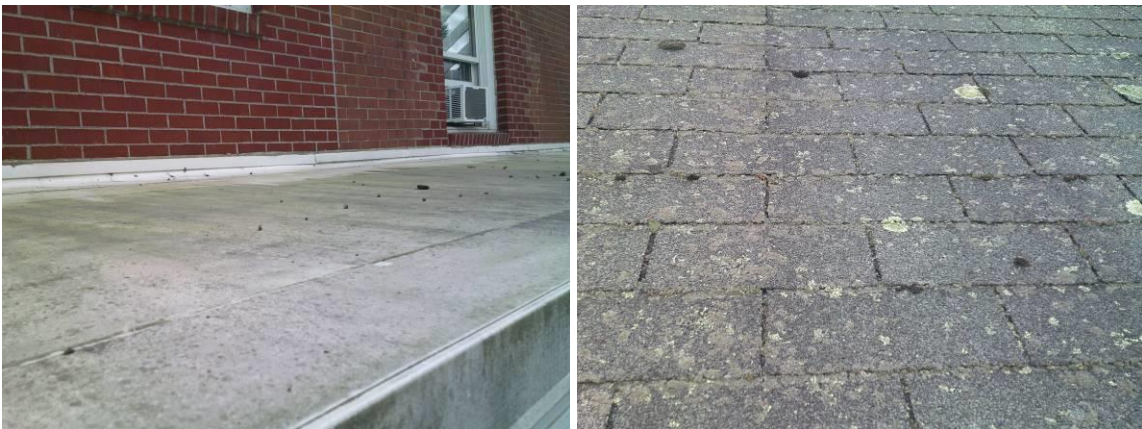
I noted discoloration from algae/moss growth at several areas, and particularly at the north pitch. While less than ideal aesthetically, this growth should not be considered a functional problem. I recommend against removing or treating the algae/moss, as it

may cause shingle damage and necessitate premature replacement.

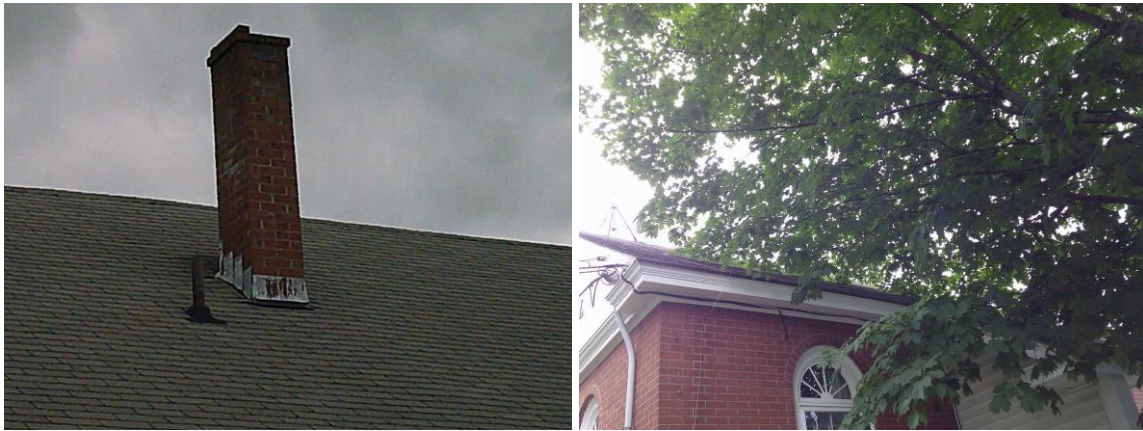
I noted brick deterioration at the chimney during my inspection. I recommend repair. Also, I recommend installing a cap to help prevent water, pest and debris entry into the flue, and to reduce chimney deterioration over time.

Further, I noted a tree that was growing too closely to the roof surface at the southwest portion, risking potential damage and creating an environment encouraging deterioration. I recommend trimming vegetation to create at least a four foot clearance at roofing surfaces.
