Vermont Historic Preservation Grants 2021 Application

Historic Name: Weathersfield Elementary School, District No.1

Physical Address: 1862 VT Route 106, Perkinsville VT 05151

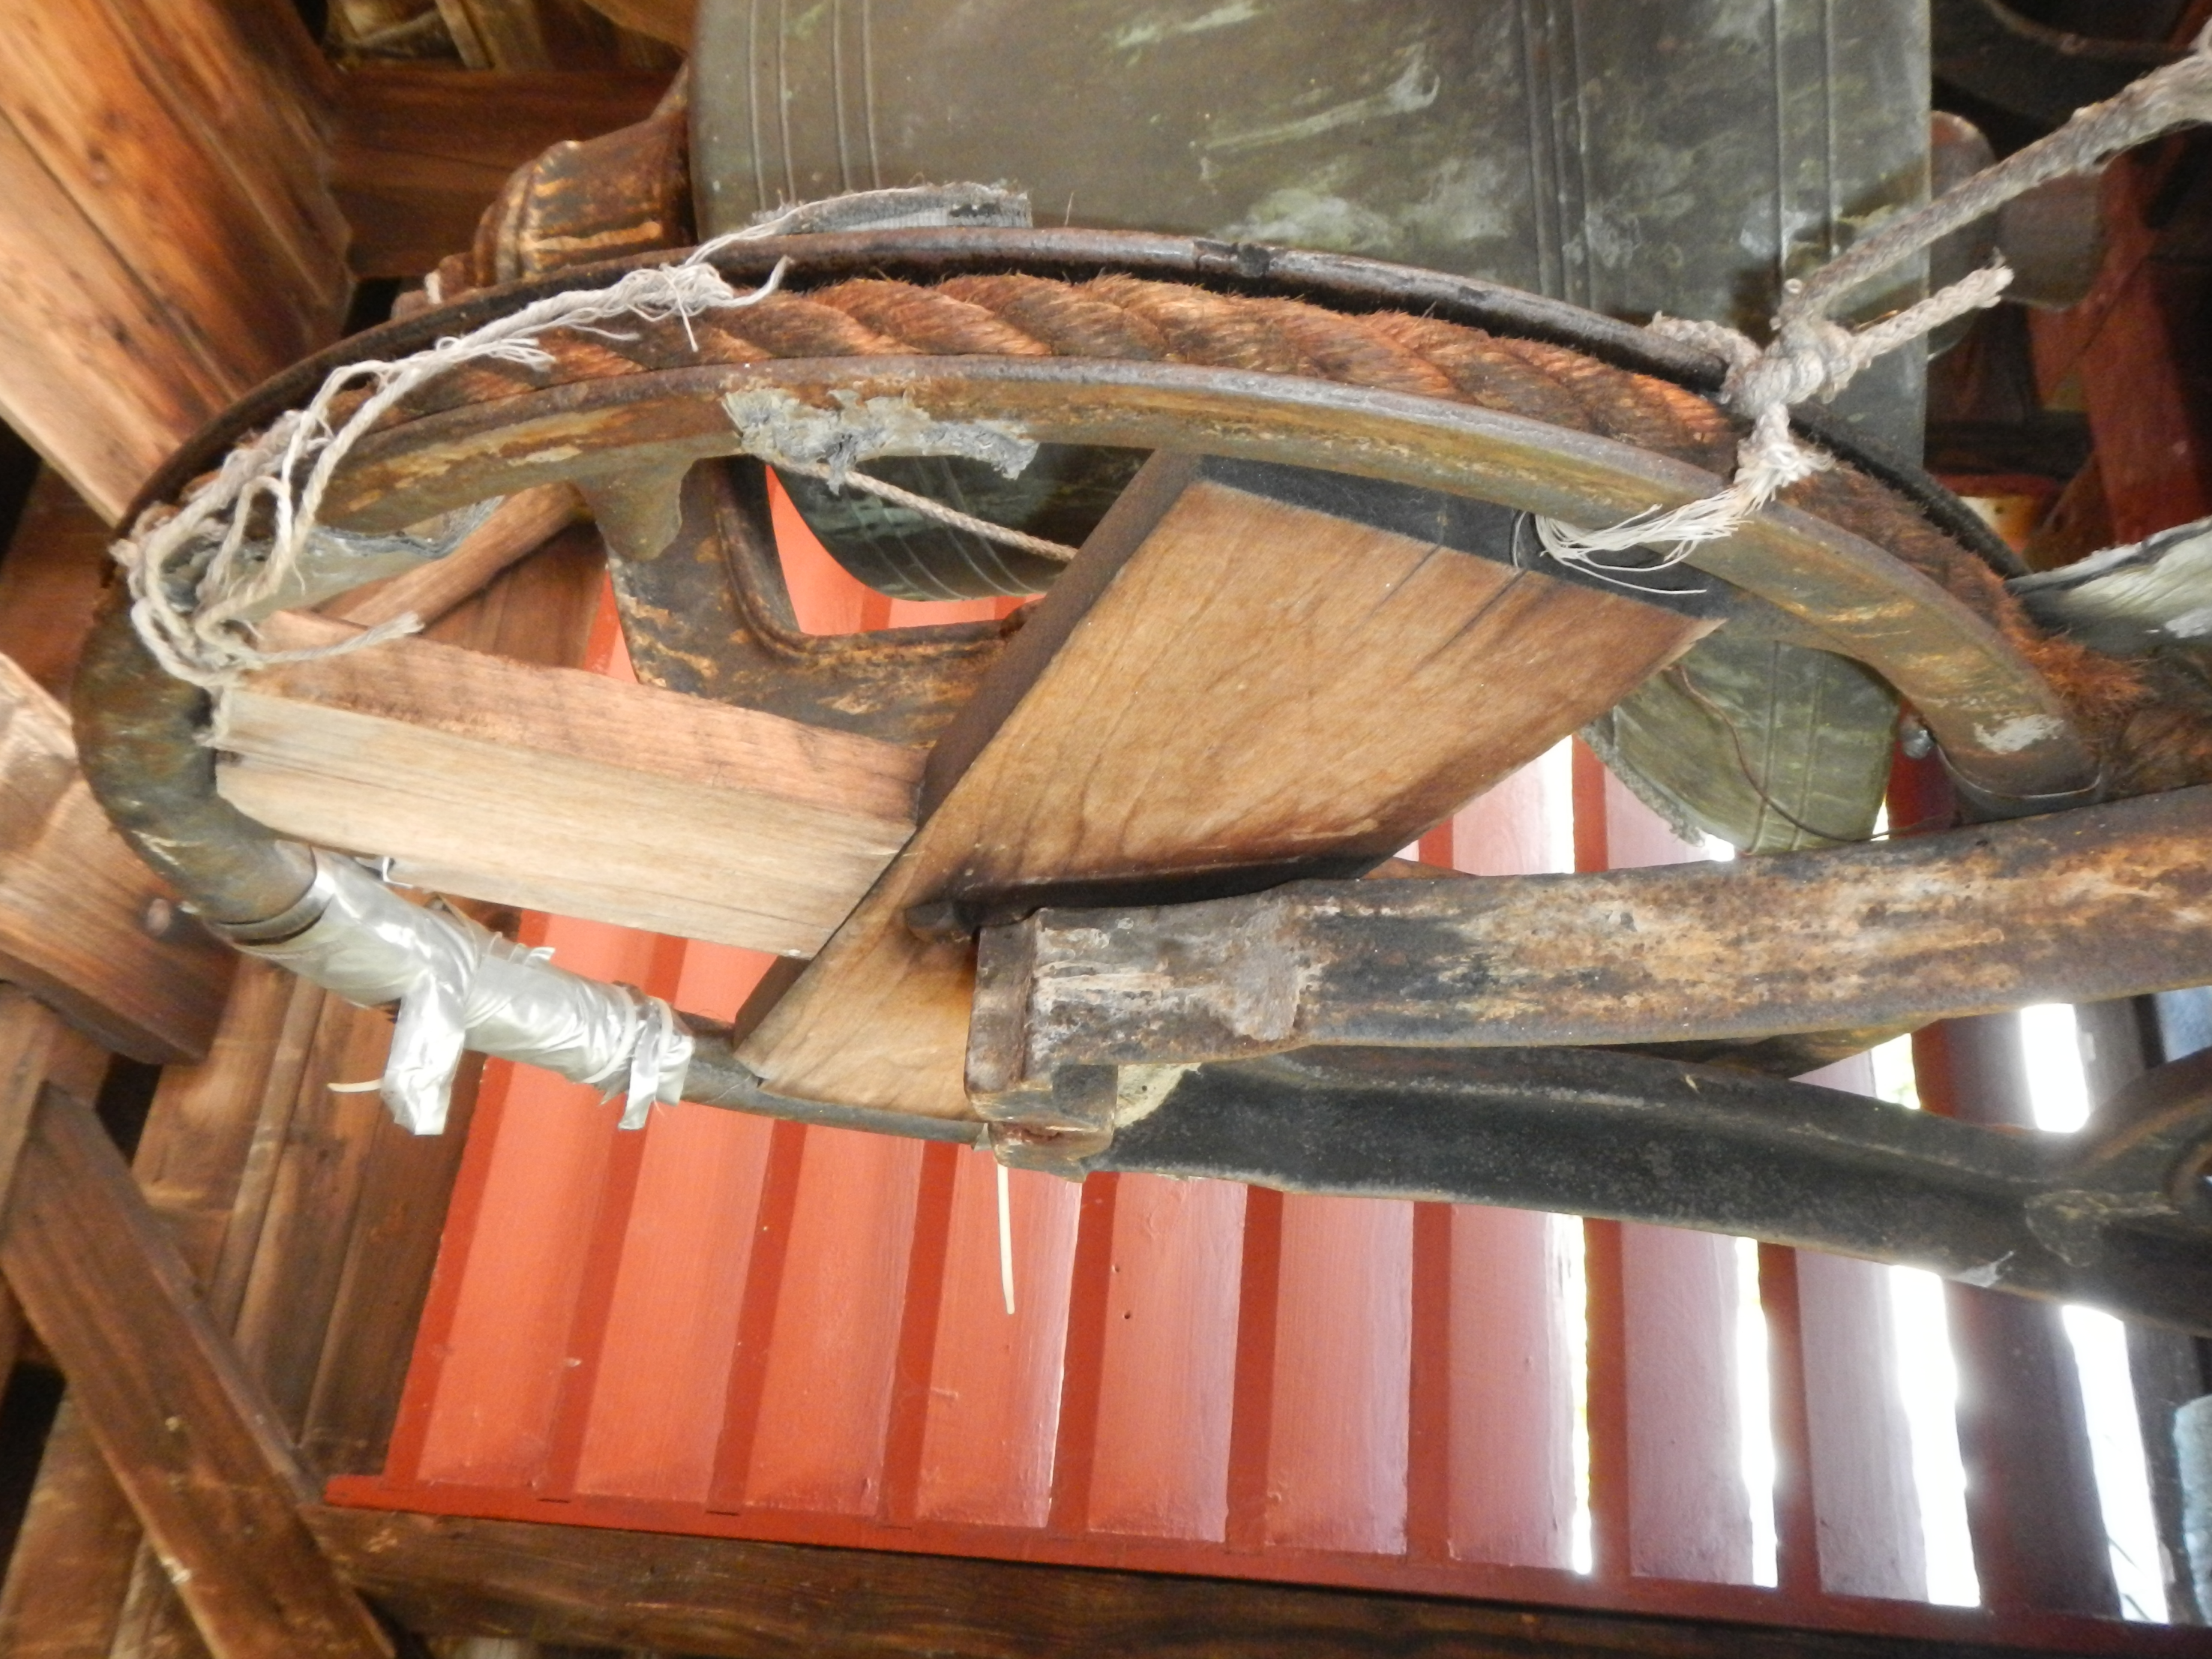
ATTACHMENT E

The cast bell ringer wheel is cracked, making it impossible to ring the (original) school bell which is still in place within the belfry.

[PHOTO 2 – CRACKED BELL WHEEL]

- Included in this project is the repair of the cast bell ringer wheel.

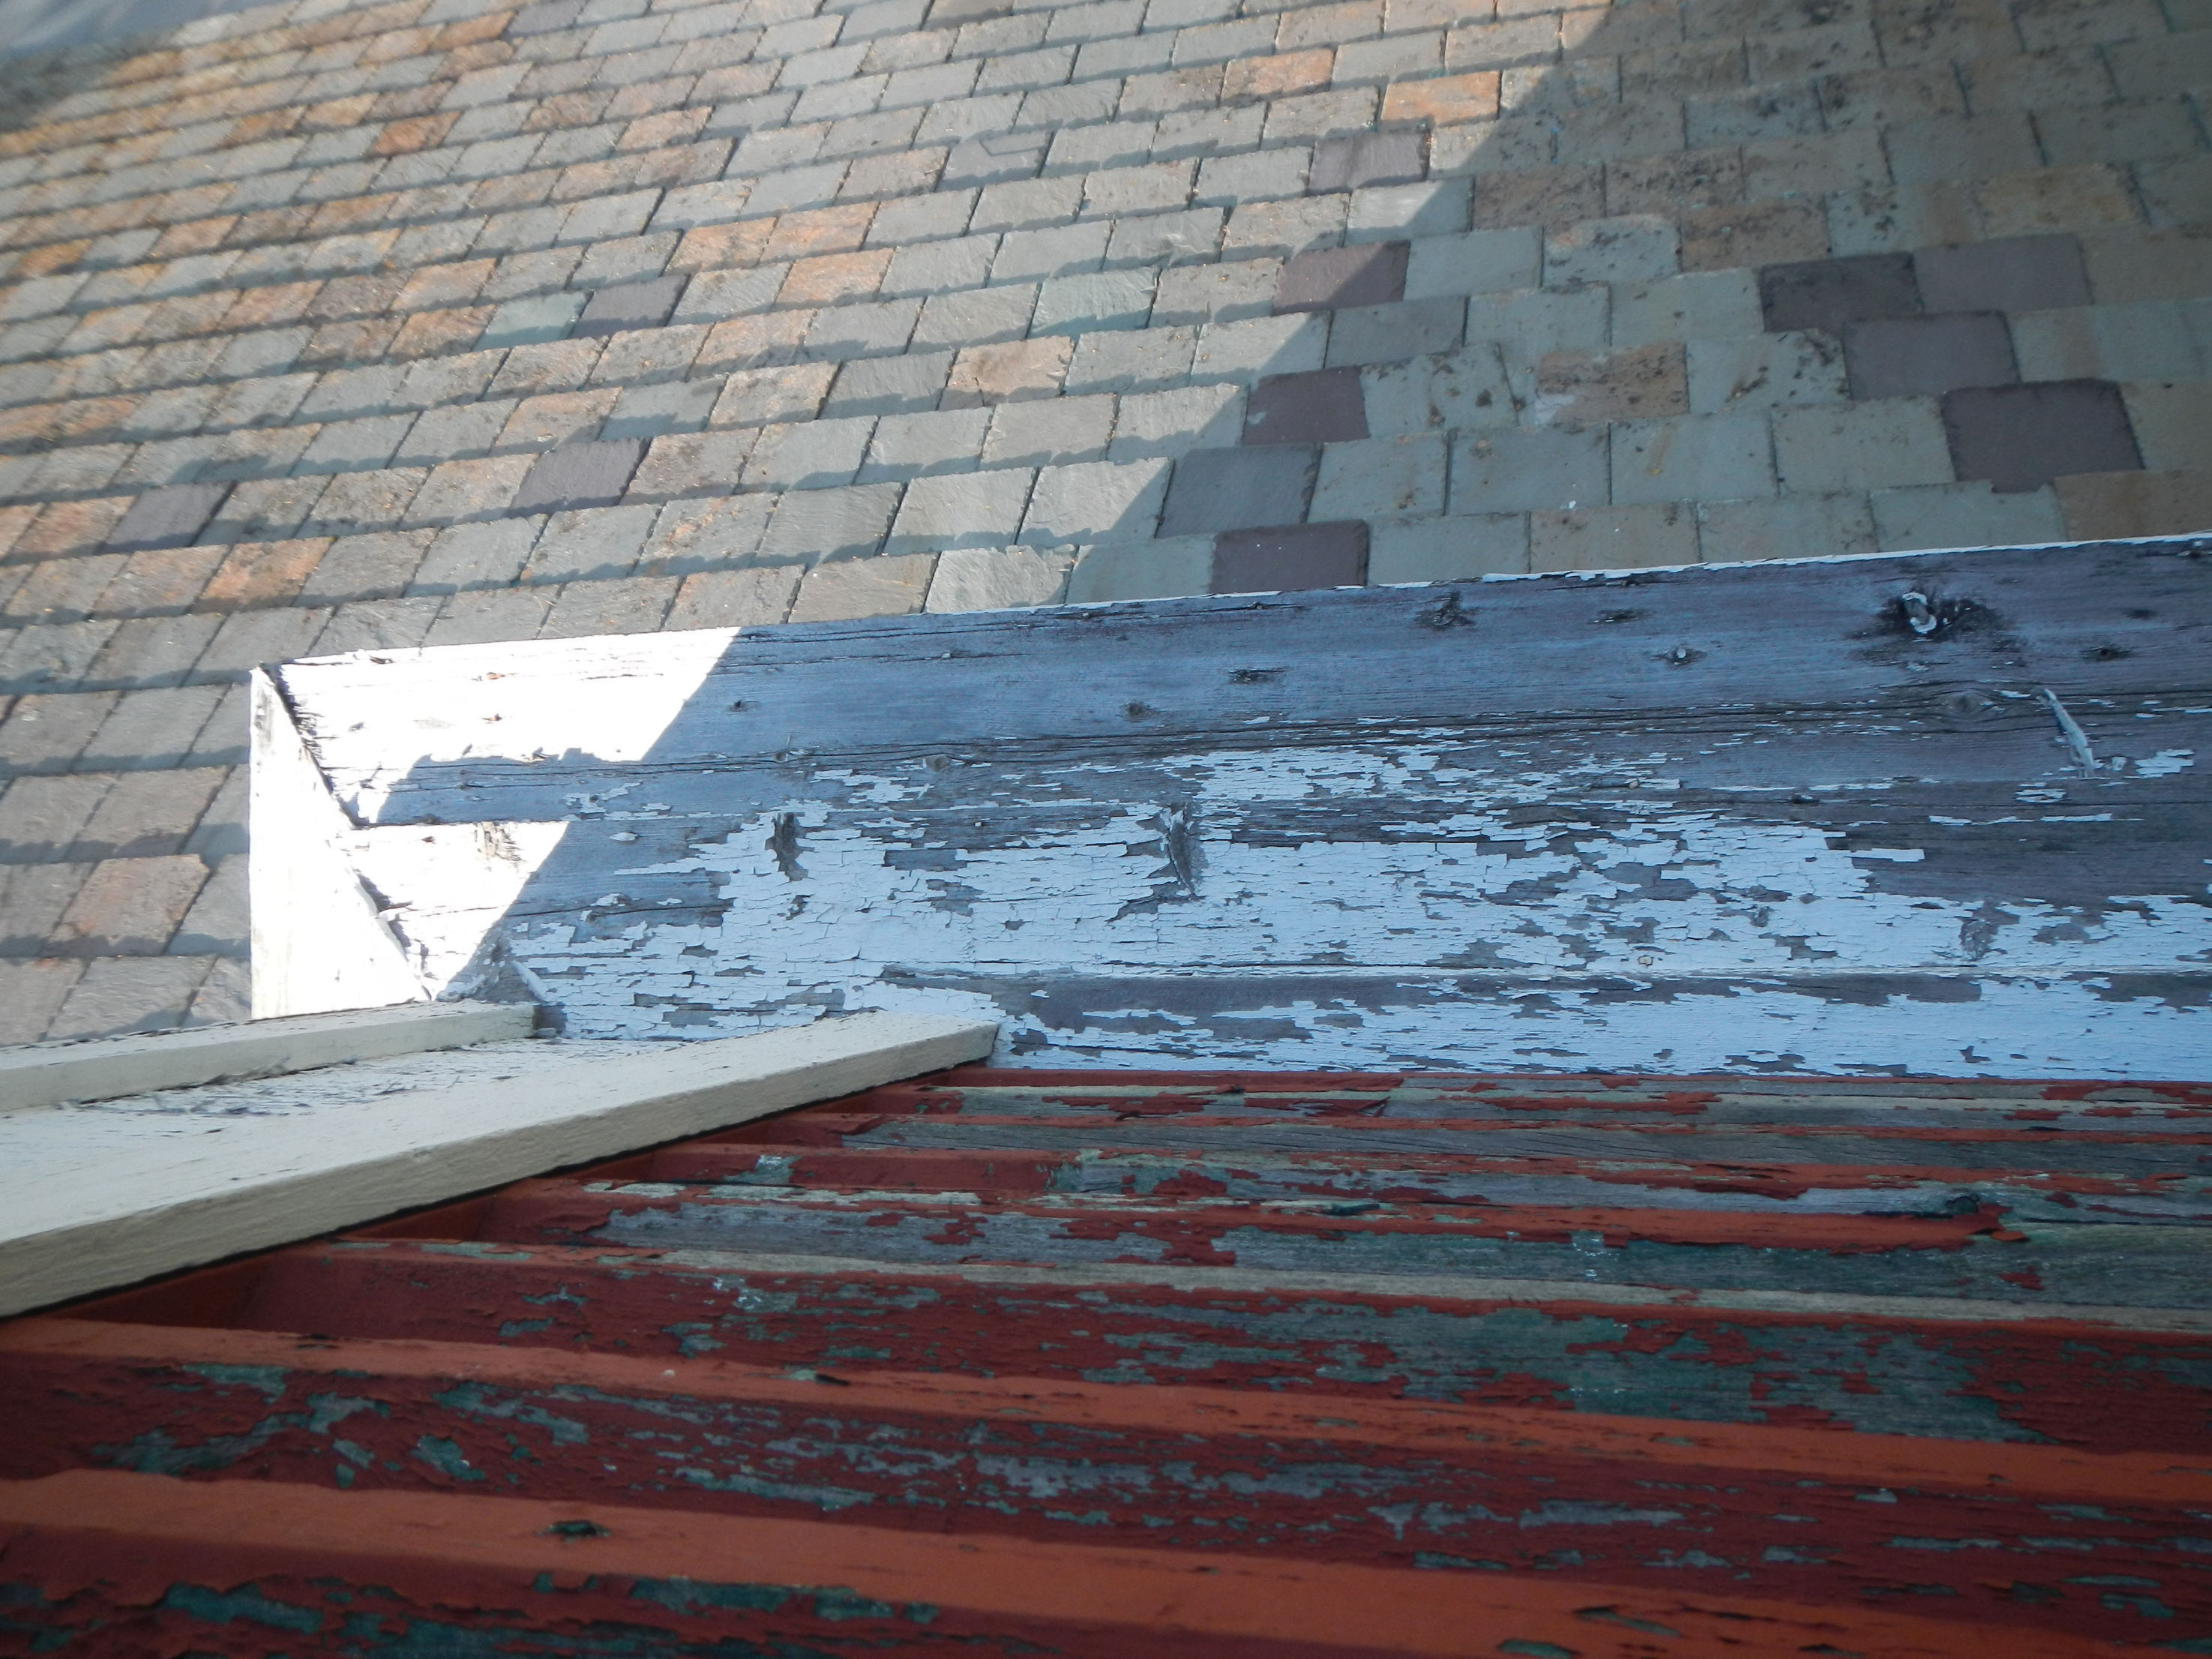
ATTACHMENT G

1. The first is structural, wherein over time there has been deflection of the rafters and roof boards due to the concentrated weight of the belfry and bell through the four main cupola support posts to the main roof structure.
2. The second is the separating corners of the flush board siding and quoins at the lower cupola corners, which is likely as a result of the settling mentioned above.
3. Third is the overall weather tightness of the cupola due to deterioration of the trim features and finish and lack of flashing at the step or shelf between the cupola base and the louvered second tier.

[PHOTO 4 – PEDESTAL LEDGE DETERIORATION]

- The use of high-quality wood epoxy fillers and epoxy consolidators will be permitted.
- New custom pre-painted aluminum flashing will be installed on the shelf between the lower tier and upper tier of the belfry. The flashing shall be brake formed with an upturn behind the facing boards and under the sills with a proper drip edge over the lower crown molding. (Note: only the drip edge portion of the new flashing will be visible from below.)

- All corners and joints will be lock seamed and sealed.
- Any structurally compromised boards forming the shelf will be replaced before flashing is installed.

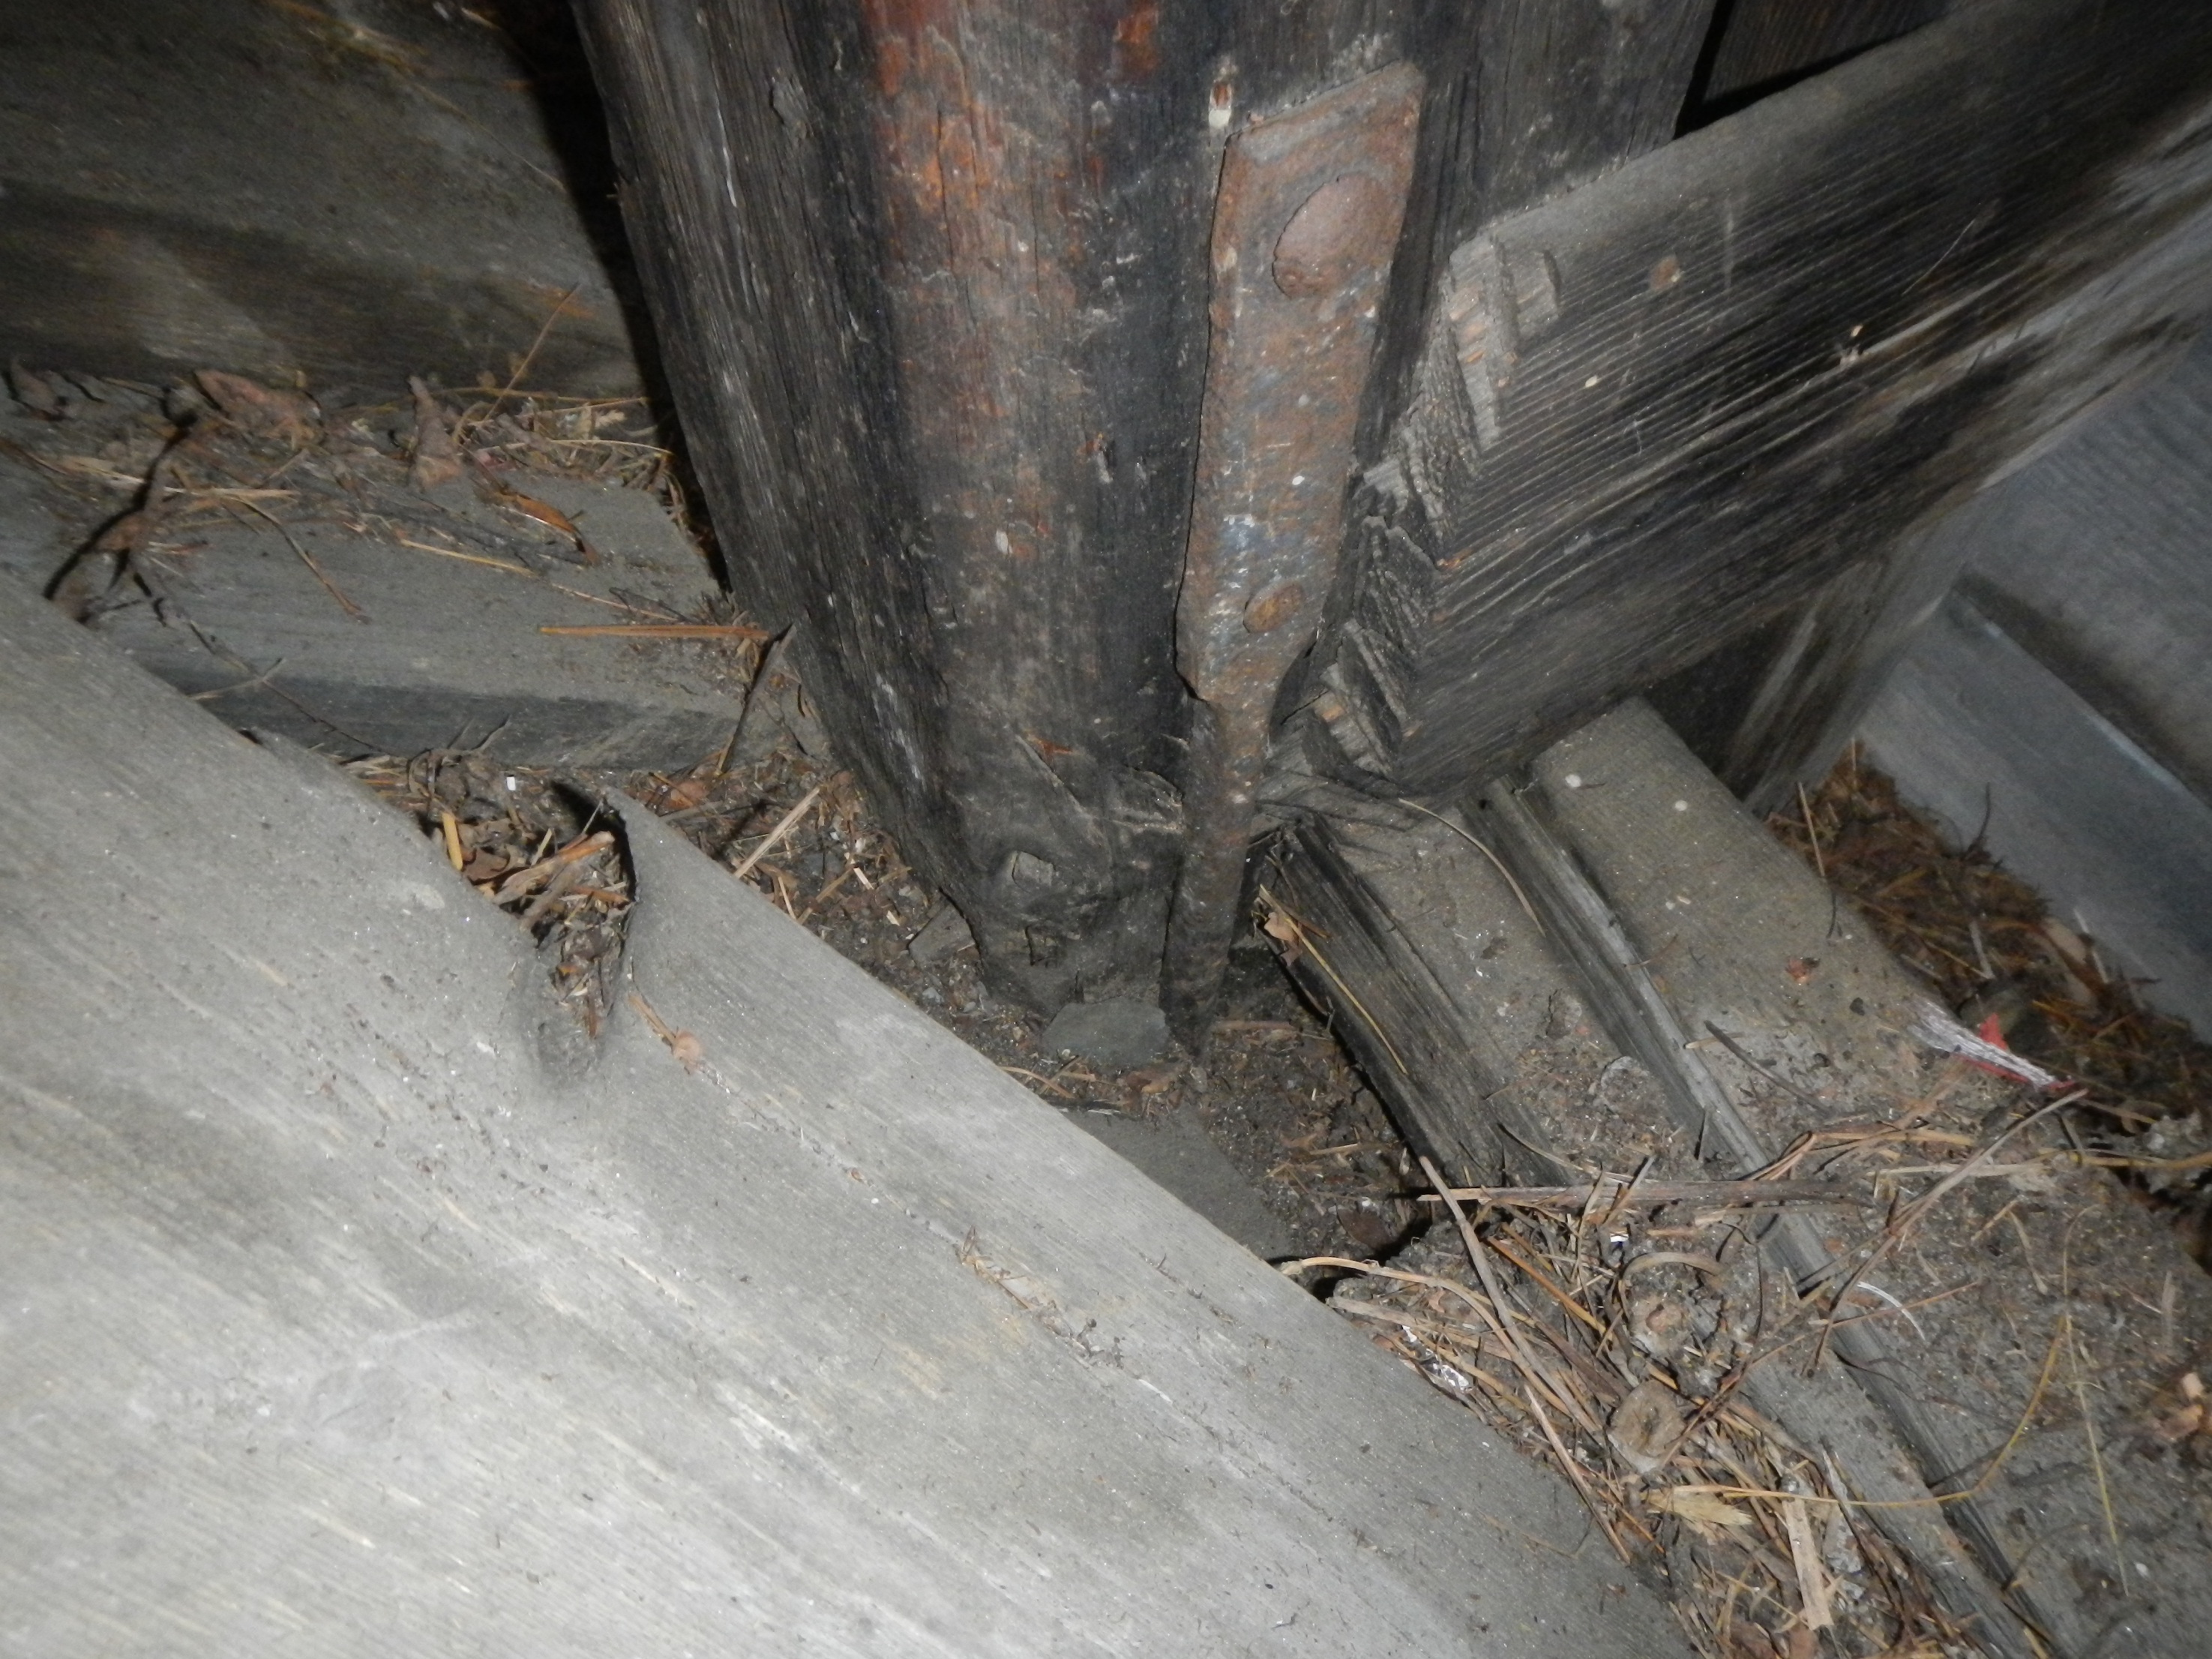
ATTACHMENT H

When originally constructed the corner supports for the belfry rested in part on the rafters and partly on the 1" thick roofing boards.

[PHOTO 5 – PEDESTAL RESTING ON ROOF BOARDS]

- Extra support framing will be added between two of the rafter bays.
- The threaded iron anchor rods will be secured and tightened to bring the lifting spreader flush with rafters.
- Steel corner braces or wooden gussets will be installed inside the belfry to stabilize the main support columns and resist future spreading. These will not be visible from the outside.

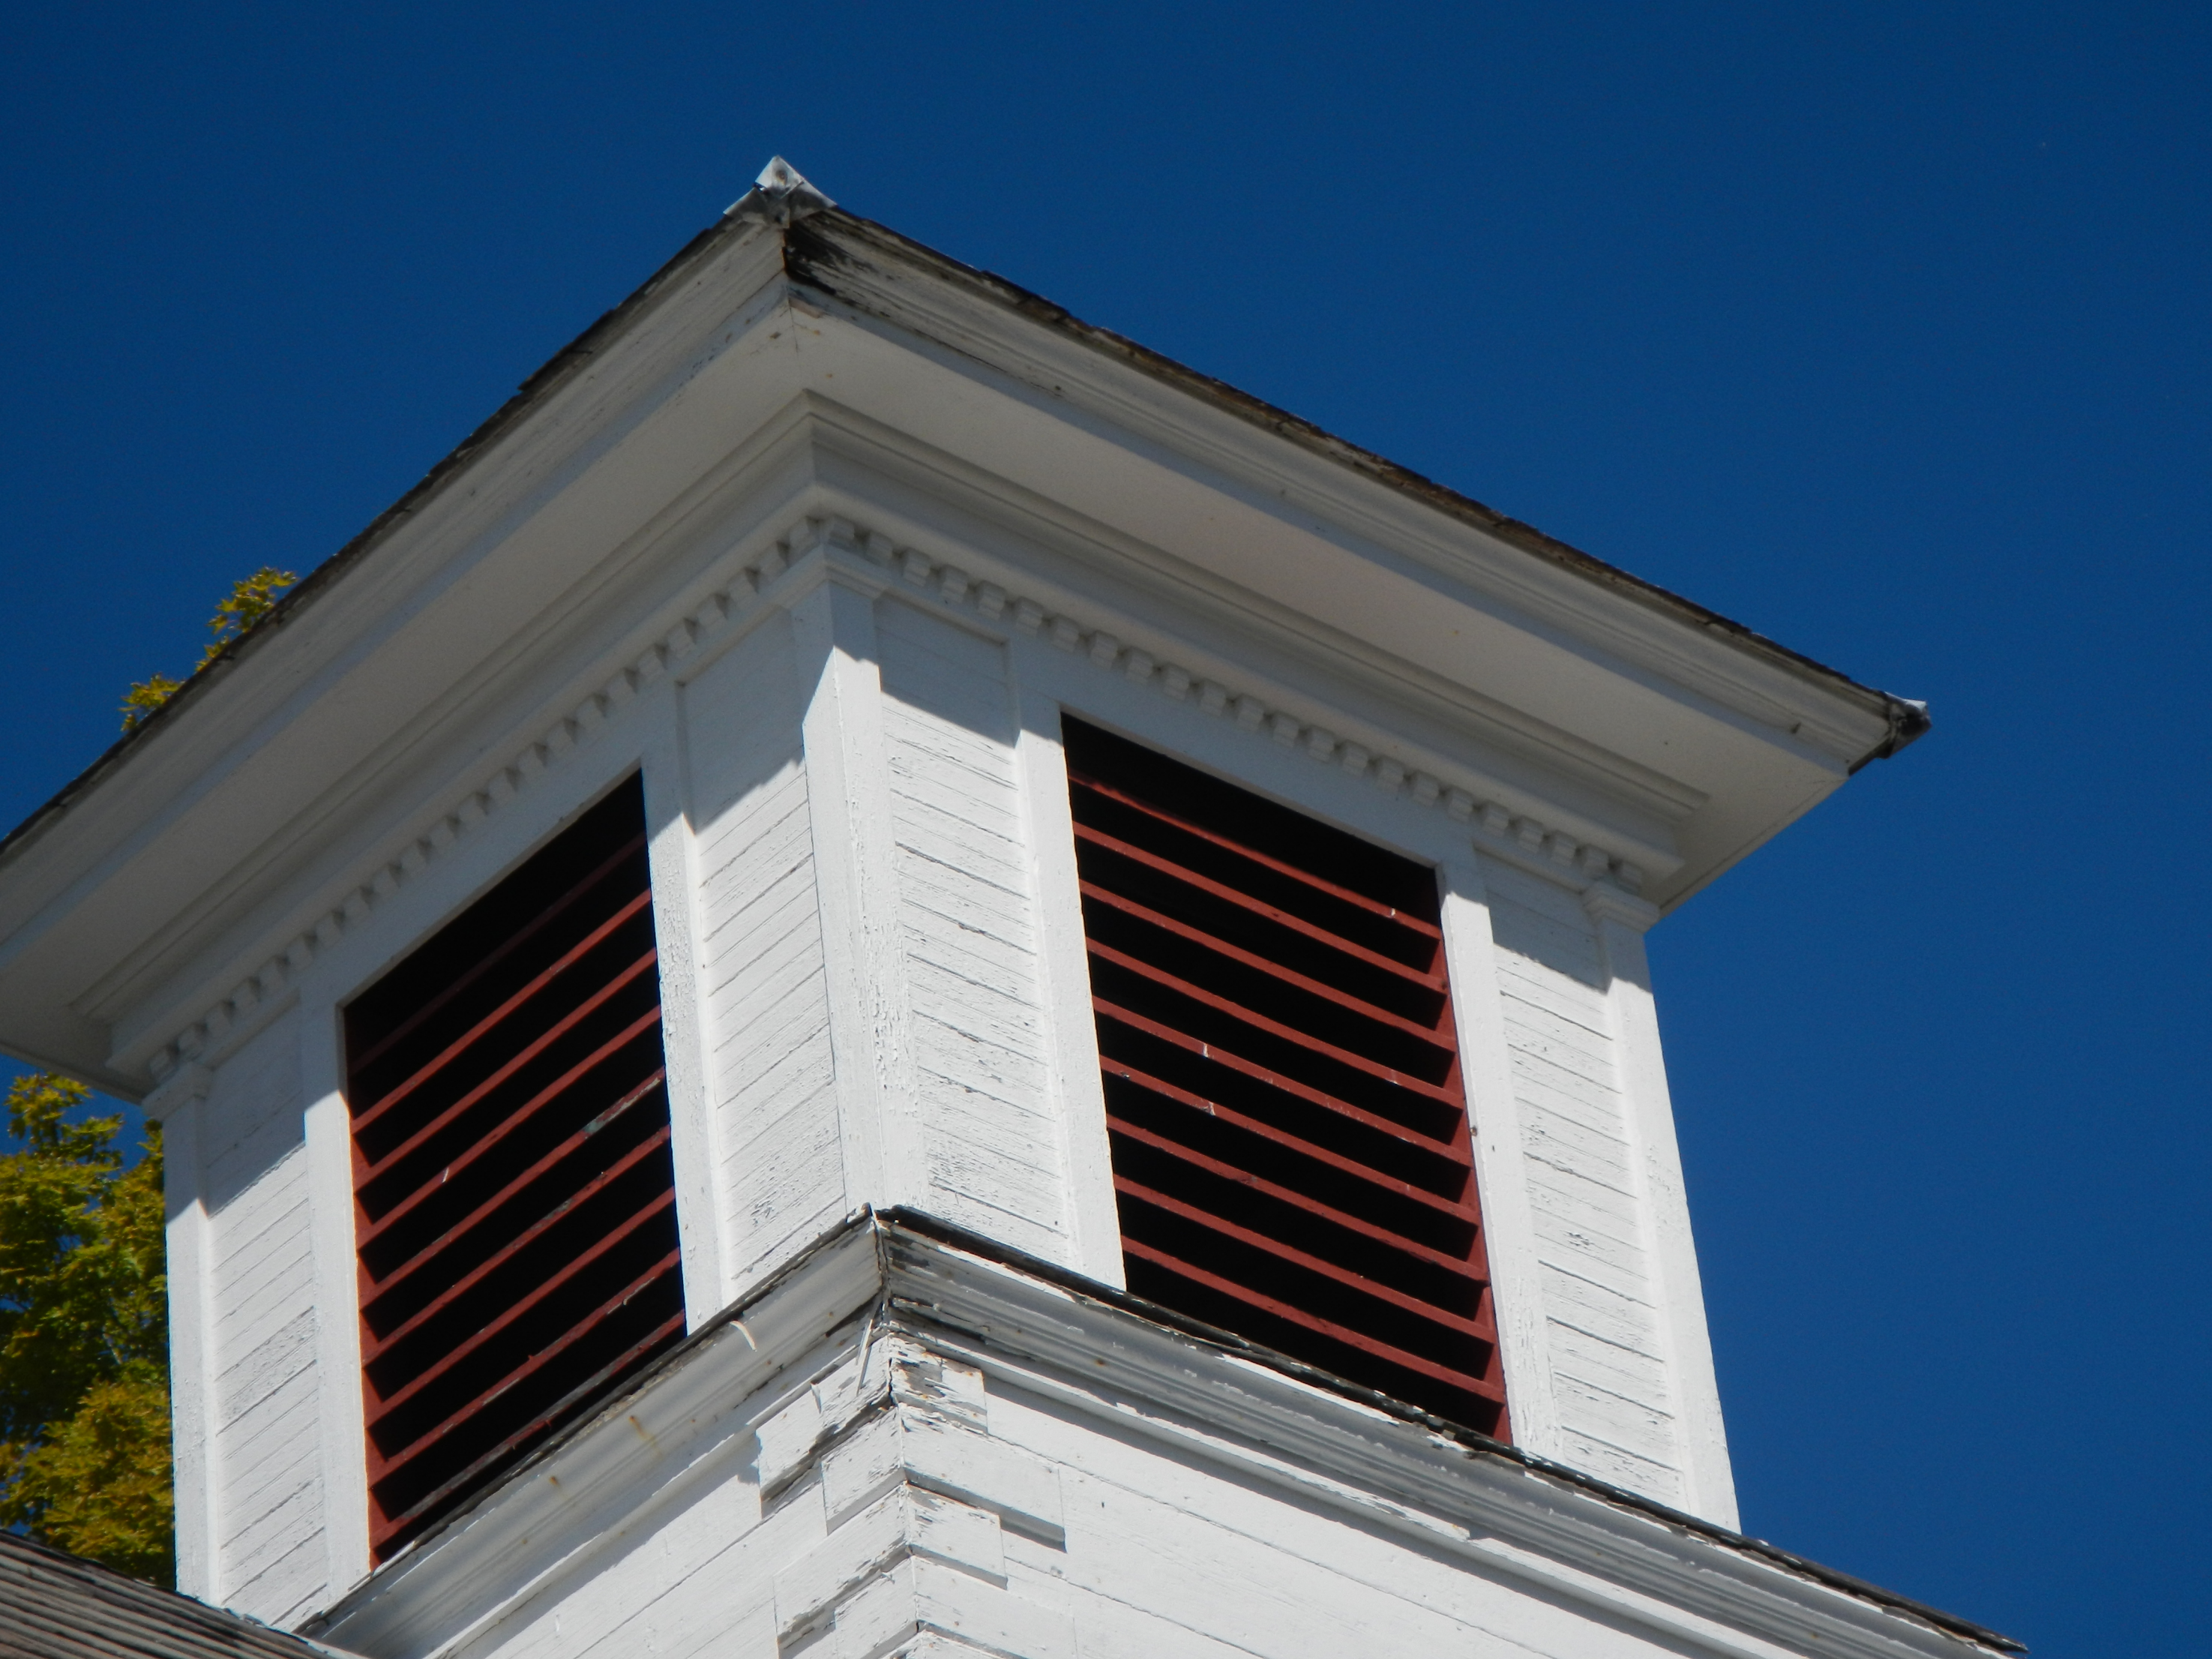
ATTACHMENT I

[PHOTO 6 – PEDESTAL TRIM DETERIORATION]

- The two lowest rows of flush board siding of the lower tier will be replaced with similar width and thickness planed pine boards.
- The two lowest wooden corner quoins in all four corners will be replaced with matching quoins as well as any others that have deteriorated and are unable to be fastened securely at the corners and refinished.
- Remaining flush board siding and quoins will be refastened to correct any separation at the corners.
- Gaps between the mated edges of the original flush board siding will not be corrected, but the gaps will be cleaned of old finish and caulking to allow for new caulking prior to painting.

- A minimum of a ½" space shall be left between the lower flush board siding boards and quoins and the roofing and flashed behind with upturned lead flashing as permitted by the removal of the boards.

- All lower tier and upper tier crown molding will be replaced with similar molding or restored as feasible with corners joints tight and able to hold finish.

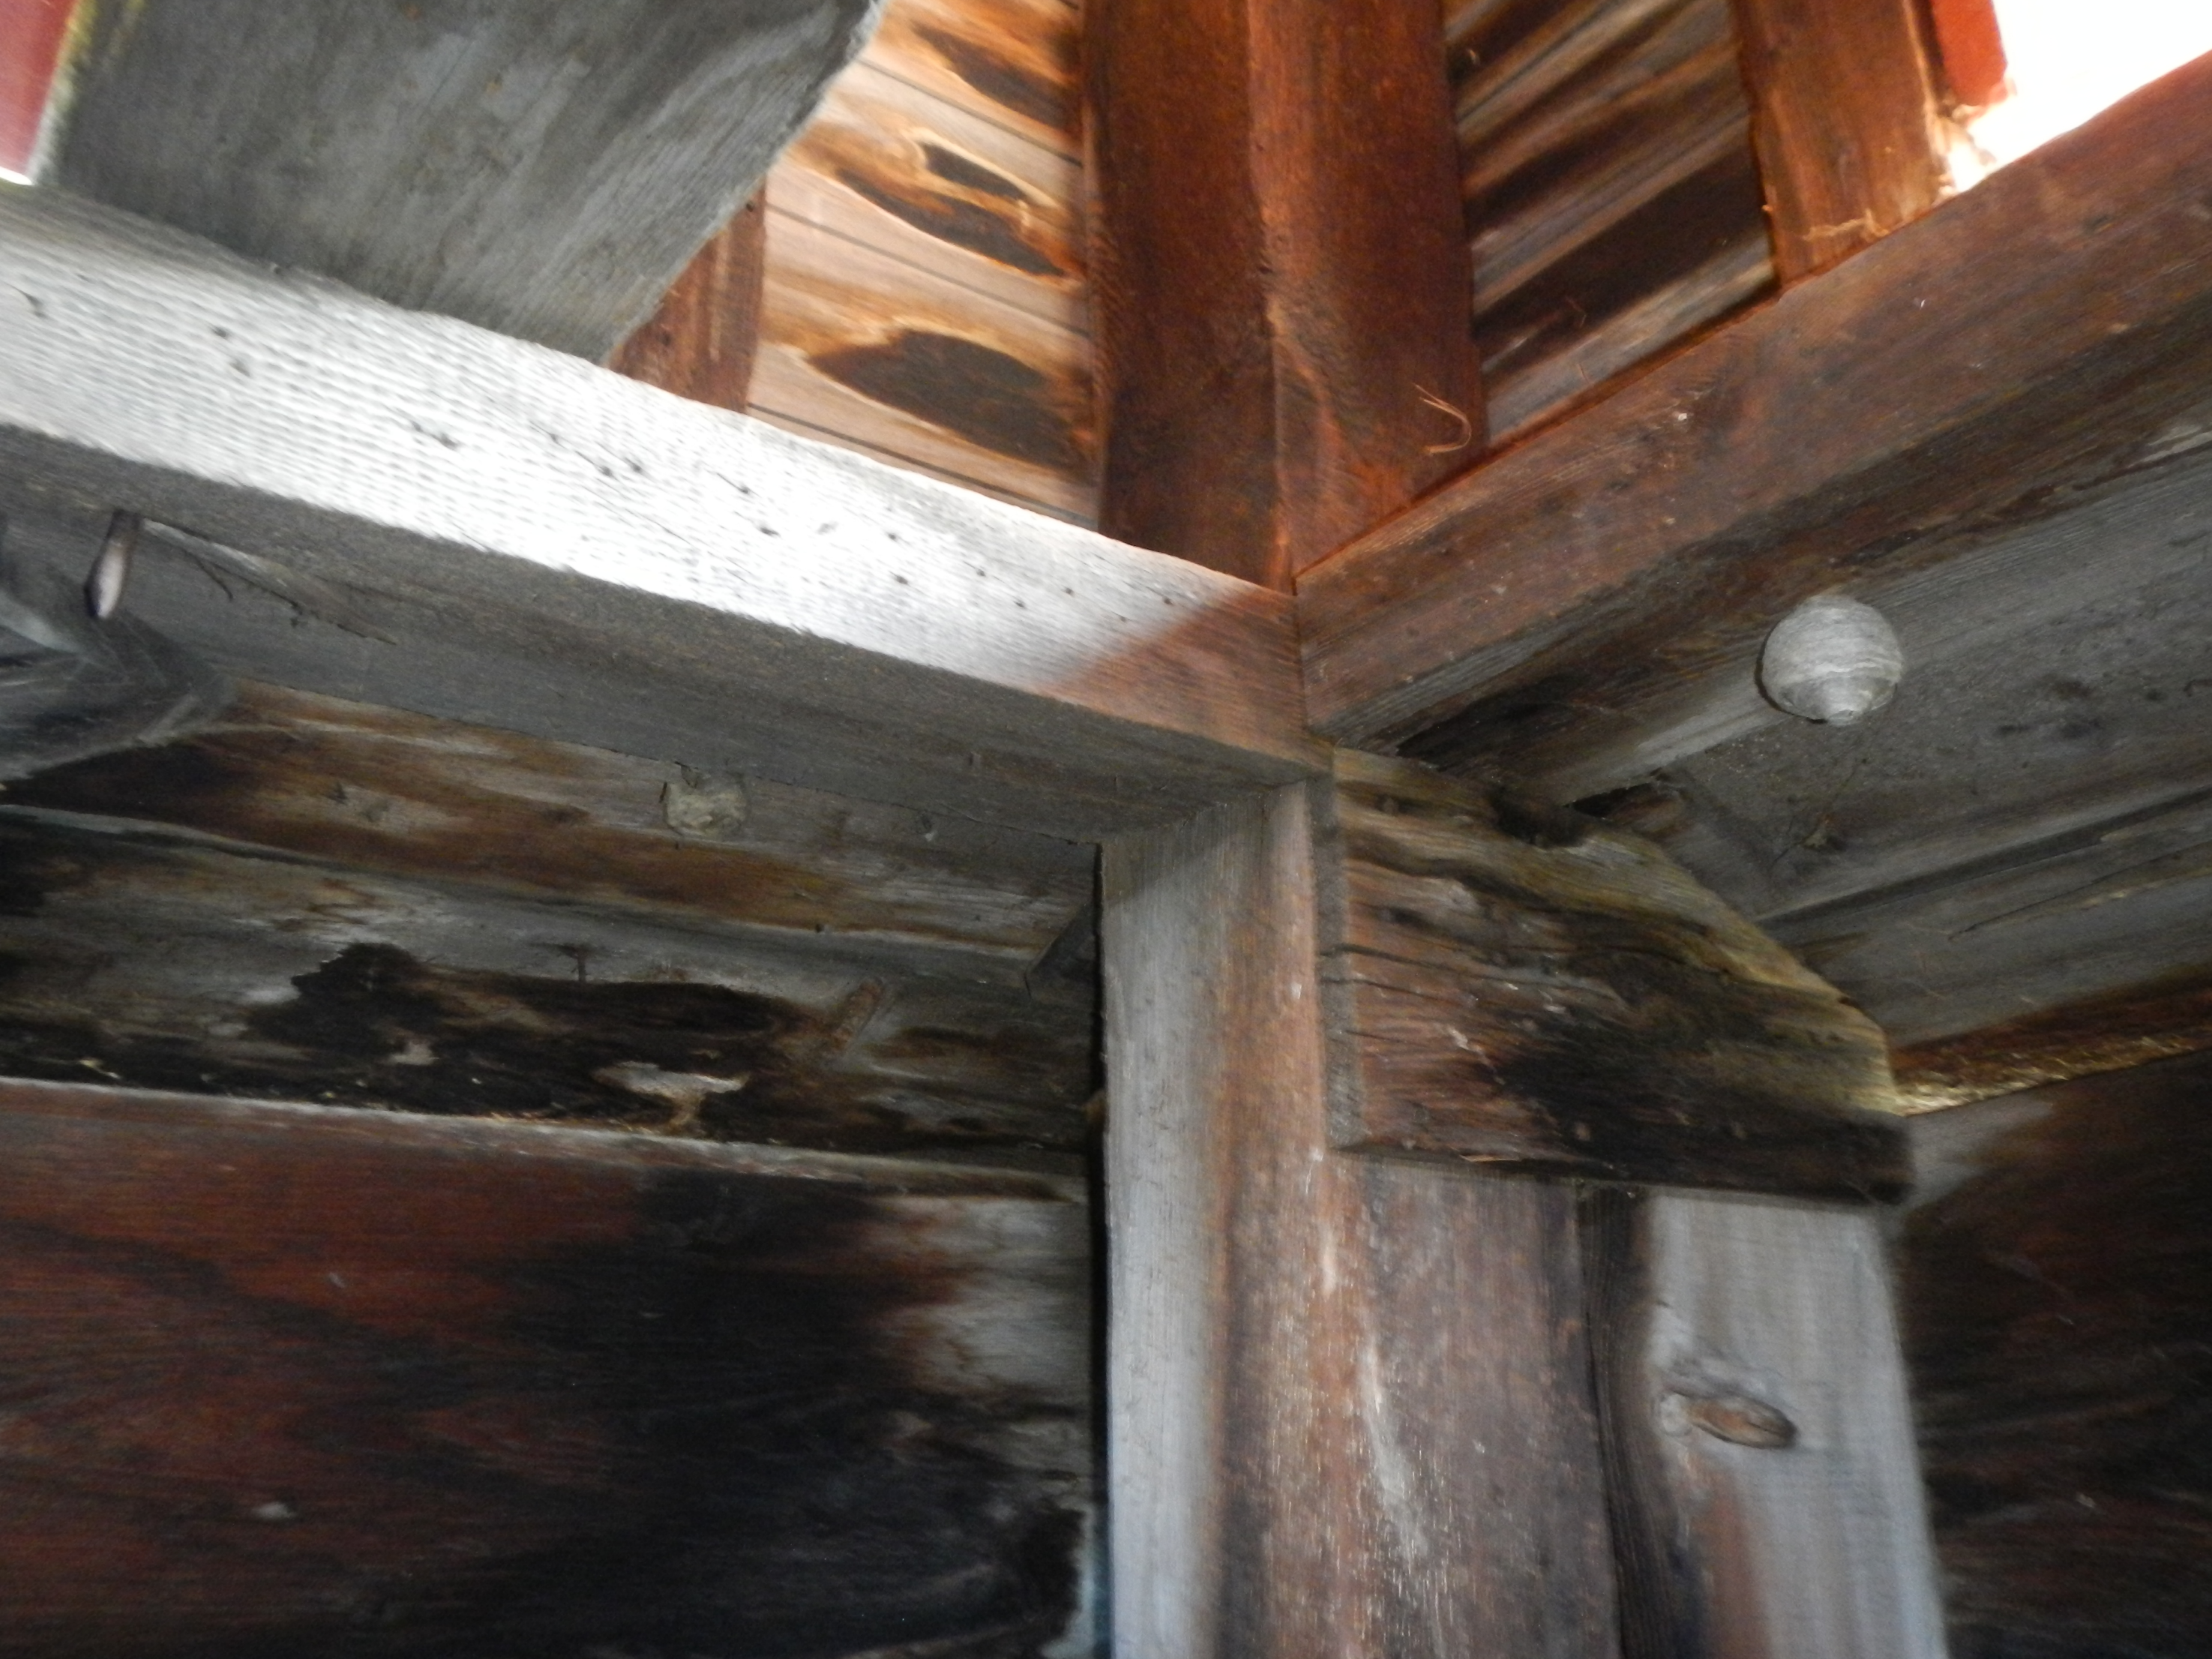
ATTACHMENT J

[PHOTO 7 – SPREADING STRUCTURE]
