Vermont Historic Preservation Grants 2021 Application

Historic Name: Weathersfield Elementary School, District No.1

Physical Address: 1862 VT Route 106, Perkinsville VT 05151

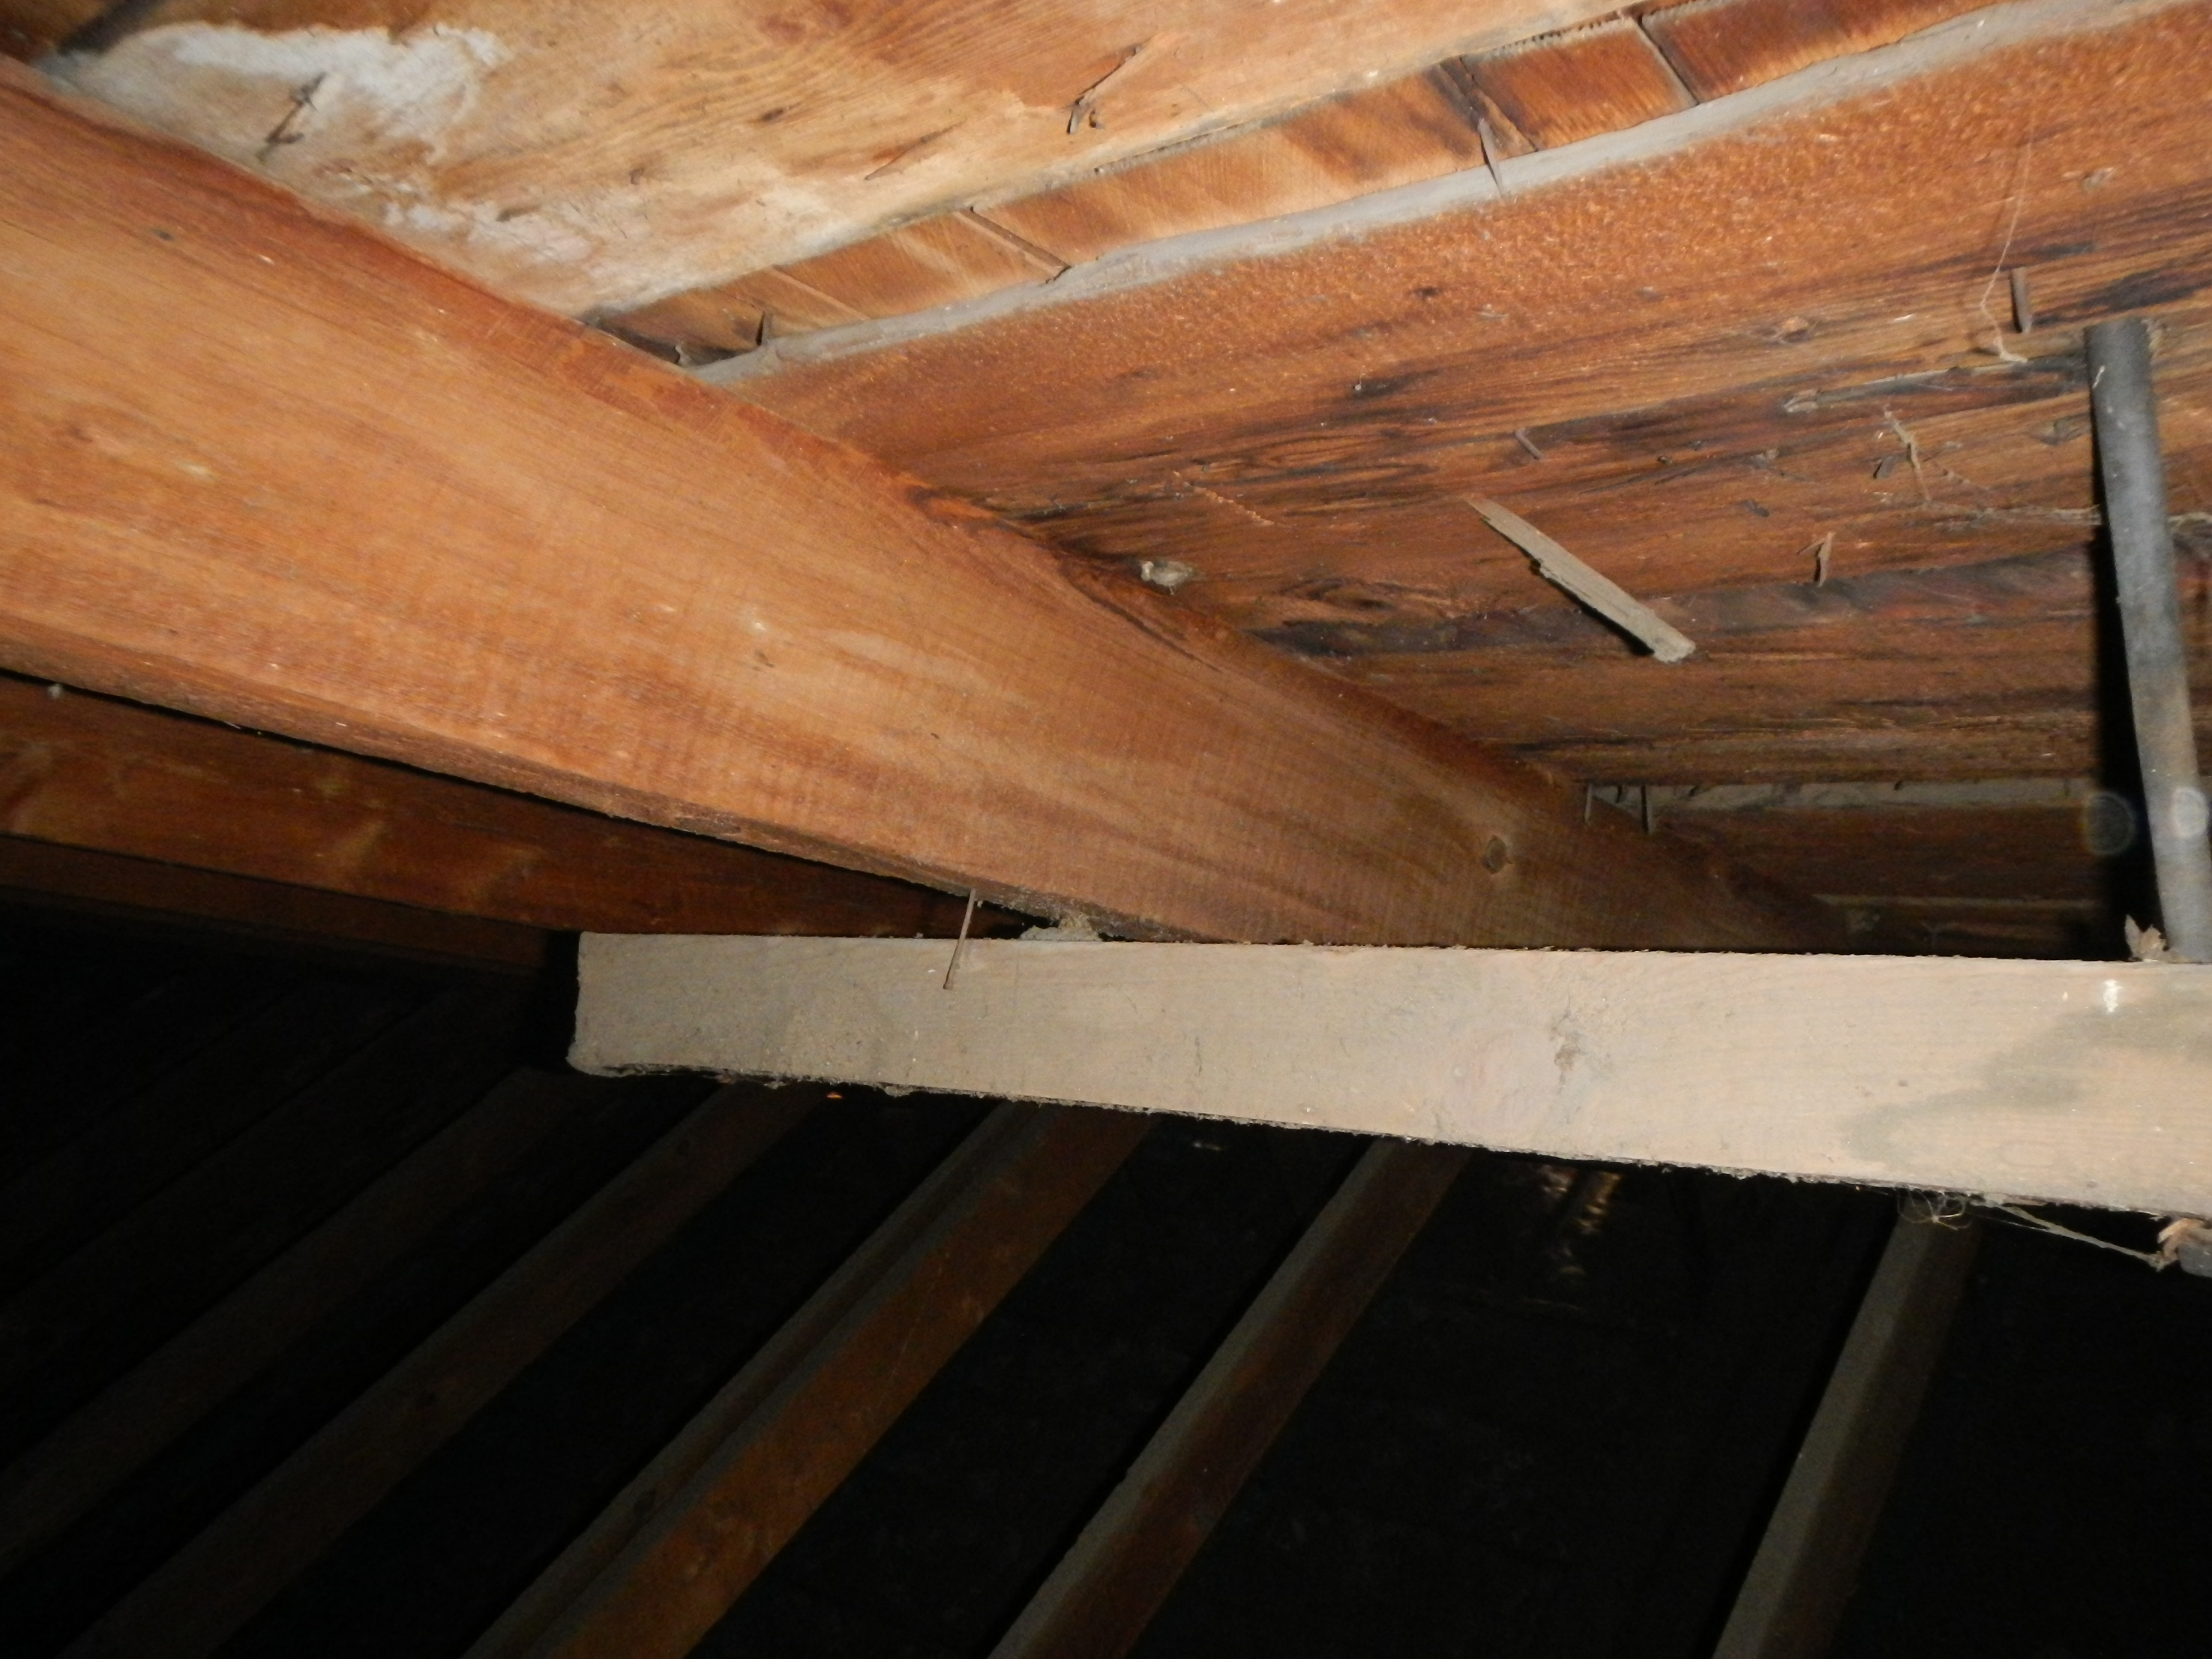
ATTACHMENT K

1. The first is structural, wherein over time there has been deflection of the rafters and roof boards due to the concentrated weight of the belfry and bell through the four main cupola support posts to the main roof structure.
2. The second is the separating corners of the flush board siding and quoins at the lower cupola corners, which is likely as a result of the settling mentioned above.
3. Third is the overall weather tightness of the cupola due to deterioration of the trim features and finish and lack of flashing at the step or shelf between the cupola base and the louvered second tier.

[PHOTO 8 - SW CORNER STRUCTURE SAGGING]

- Extra support framing will be added between two of the rafter bays.
- The threaded iron anchor rods will be secured and tightened to bring the lifting spreader flush with rafters.
- Steel corner braces or wooden gussets will be installed inside the belfry to stabilize the main support columns and resist future spreading. These will not be visible from the outside.
